# 12

## **SYSTEM AND COMPONENT EXAMPLES: SYSTEMS THAT WORKED AND WHY THEY WORKED; SYSTEMS THAT DID NOT WORK AND WHY THEY DID NOT WORK**

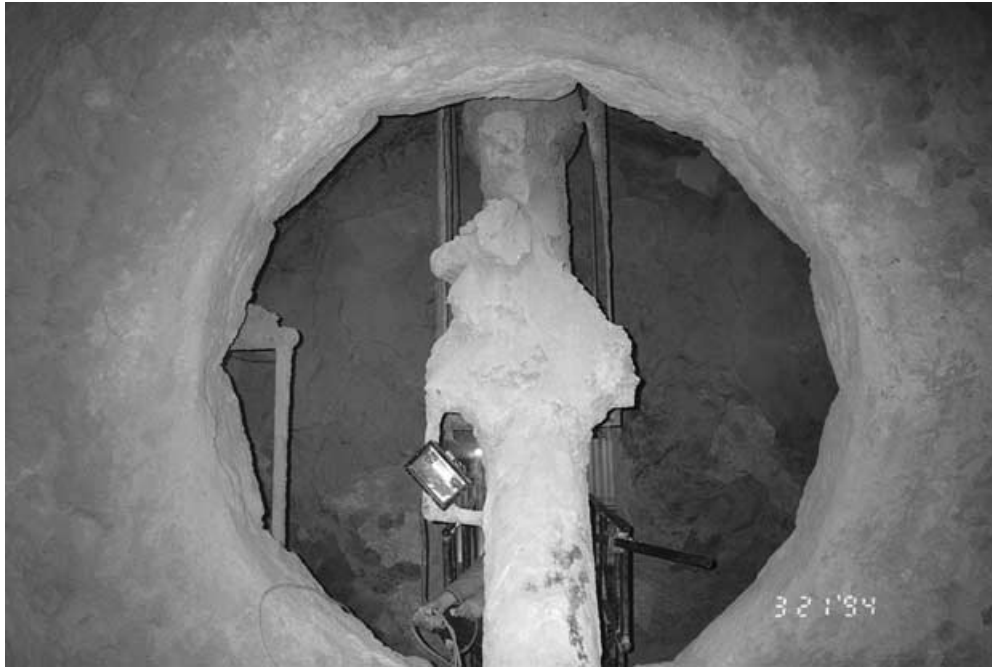
**Figure 12.2** Typical cement kiln interior (approximately 8 ft inner diameter—process analyzer sample probe is supported behind left kiln wall).

The area where the probe was installed was inside a huge building enclosing the end of the rotating cement kiln (approximately 10 ft/3 m outside diameter) and up at the fourth level above the ground (approximately 60 ft/18 m above grade). Maintenance of the probe required climbing a 10 ft/3 m ladder up to a small platform beneath the end of the probe. The ambient temperature in the area of the platform was approximately 80 to 90°F/27 to 32°C in the Iowa wintertime and probably 140 to 150°F/60 to 65°C in the Iowa summertime.

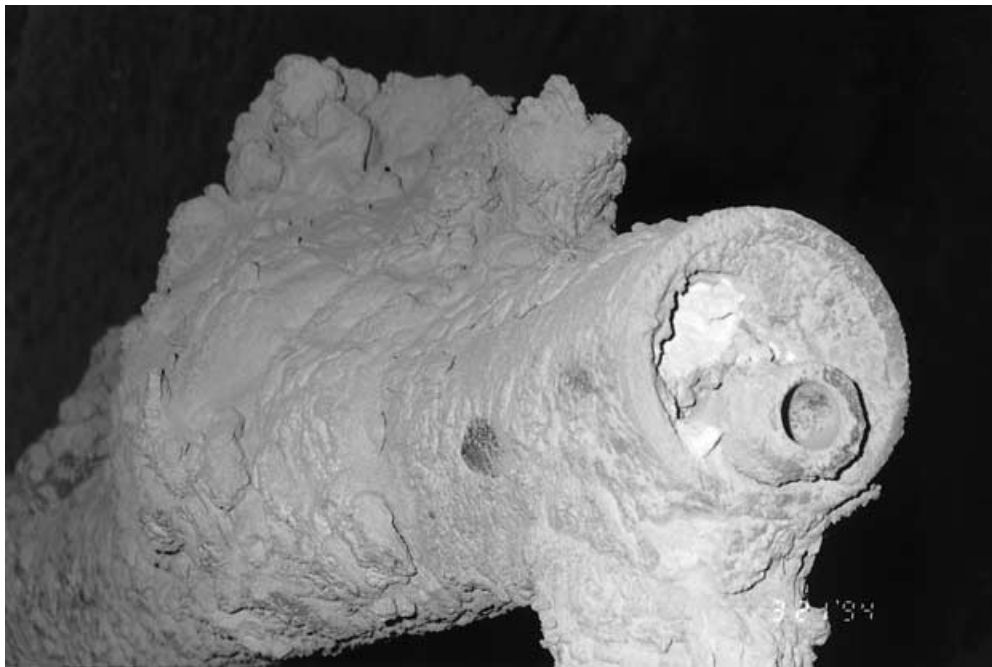
**Figure 12.3** Close-up of process analyzer sample probe (supported end). Pipe surrounding sample probe tube is approximately 4 in. outside diameter; probe sample tube is approximately 1 in. outside diameter.

The process analyzer sample probe would plug up with a concrete-like material approximately every 30 minutes, even though it had an electric heater around the probe head, blowback air connected to the probe head, and the heated probe head and blowback air valves were enclosed in an insulated probe protection enclosure. The maintenance personnel would open the probe protection enclosure, remove a threaded plug from the enclosure end of the probe assembly, insert a solid metal rod slightly smaller than the internal diameter of the probe, and proceed to hammer on the atmospheric end of the rod with a sledge hammer until it drove the concrete-like plug out of the process end of the probe and into the operating cement kiln.

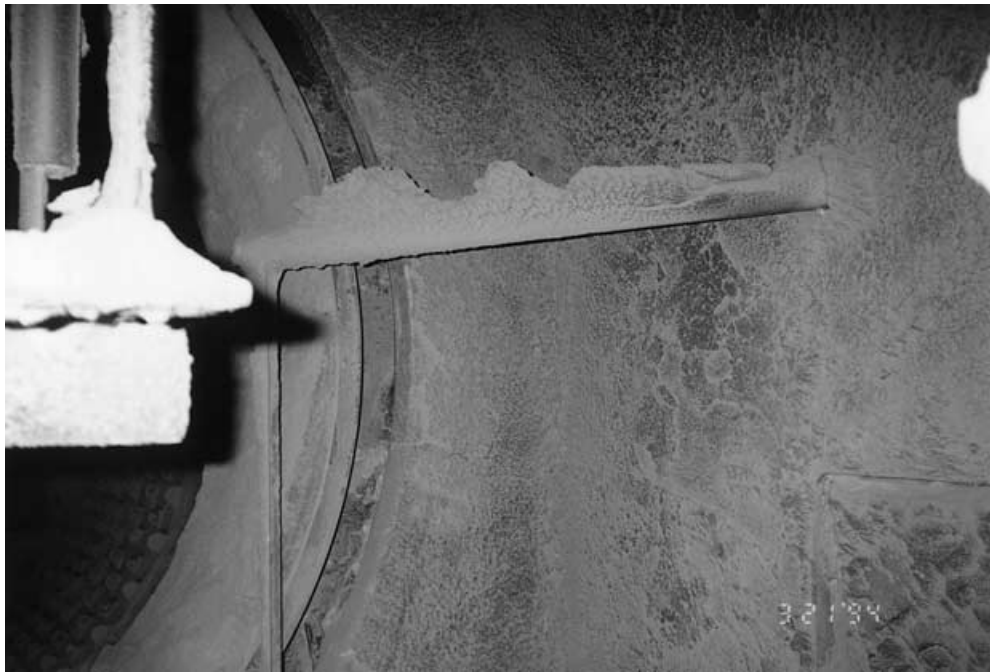
**Figure 12.4** Rear view of supported process analyzer sample probe showing process material build up (residual) and sample probe kiln header box penetration.

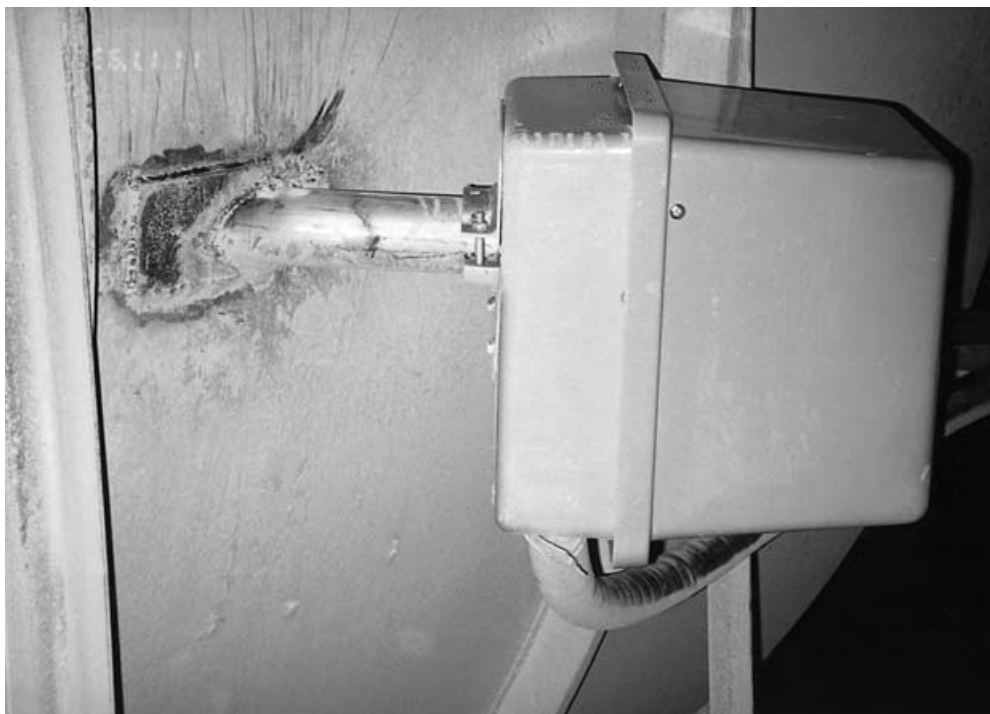
**Figure 12.5** View of process analyzer sample probe showing kiln header box exterior wall penetration detail and sample probe protection box detail. Integrally heat-traced-and-insulated process sample transfer line exits sample probe protection box from bottom of box.

Next we added two capacity tanks of approximately 0.06 cu ft/2 L each in a parallel configuration inside of the heated-and-insulated probe protection enclosure, and we changed the valve that admitted air to the process analyzer sample probe to a larger internal diameter valve with an electropneumatic operator for absolute fastest positive actuation of this valve. The prior valve in the service had been a simple electric solenoid valve with a poppet-and-seat as its flow path. We changed the blowback time duration and interval to blowing back 15 seconds every 10 minutes. Even though this process analyzer system was being utilized for kiln operation control, its primary purpose was as a CEMS (continuous emissions monitoring system) to meet USEPA reporting requirements and this required 7 minutes of good and steady data out of every 15 minute time period. Thus we could not blowback, as an example only, 10 seconds every 3 minutes. This frequent blowback interval would upset process analyzer sample flow and put an artifact on the output of each process analyzer signal, which would disrupt the 7 minute require-

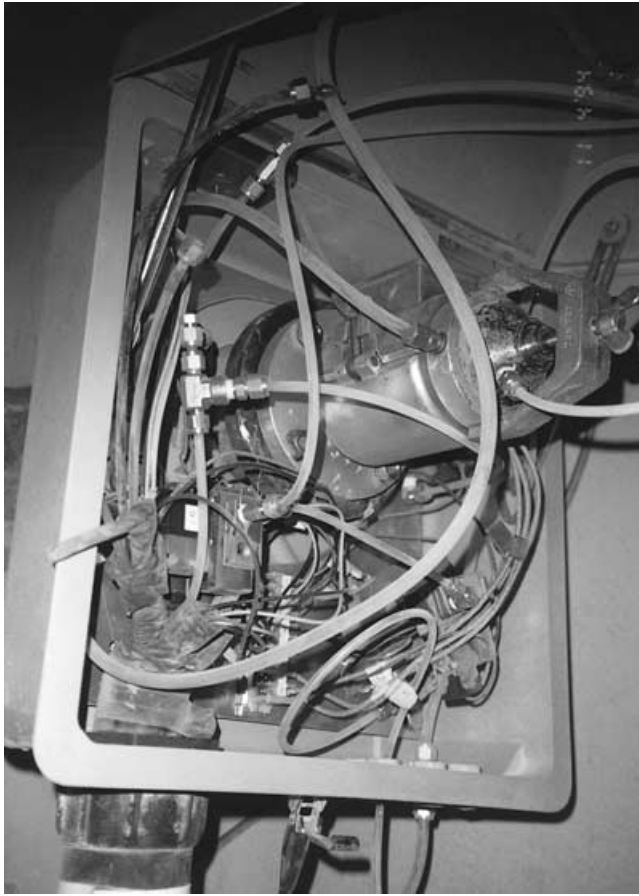
**Figure 12.6** View of interior tubing and wiring surrounding sample probe heated filter. Integrally heat-traced-and-insulated process sample transfer line exits sample probe protection box from lower-left bottom of box.

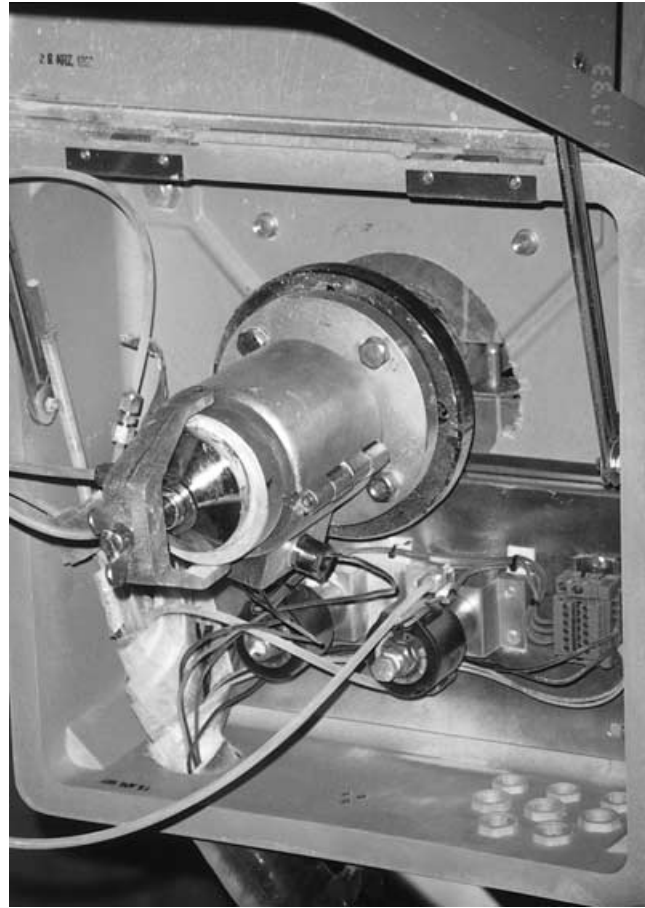
**Figure 12.7** Sample probe protection box (interior view) with sample probe heated filter (center). Integrally heat-traced-and-insulated process sample transfer line exits sample probe protection box from lower-left bottom of box.

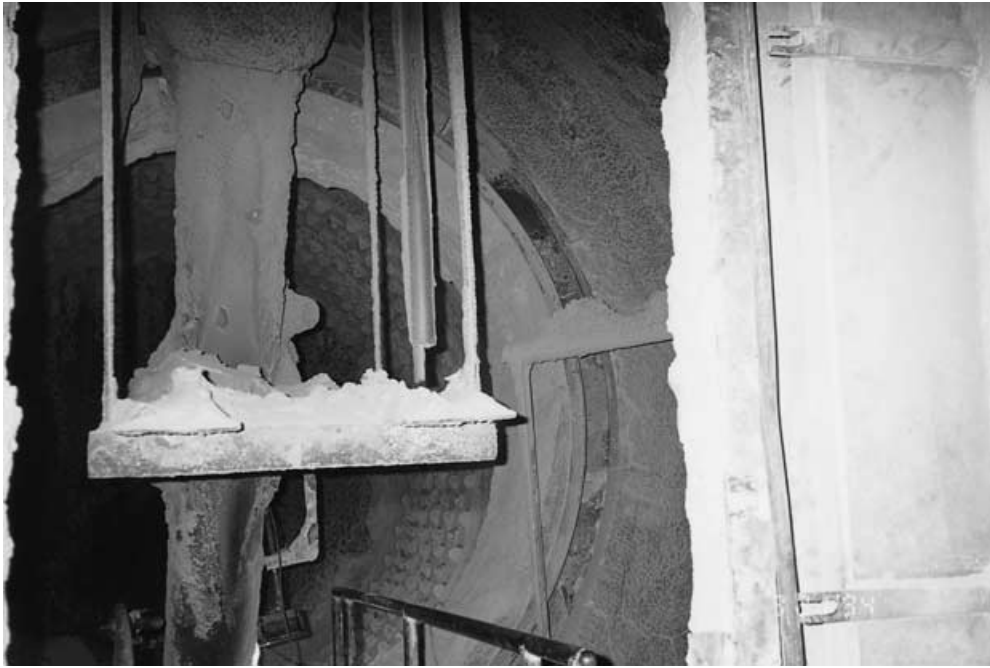
**Figure 12.8** Kiln interior showing water injection cooling lance in lower right (below probe support).

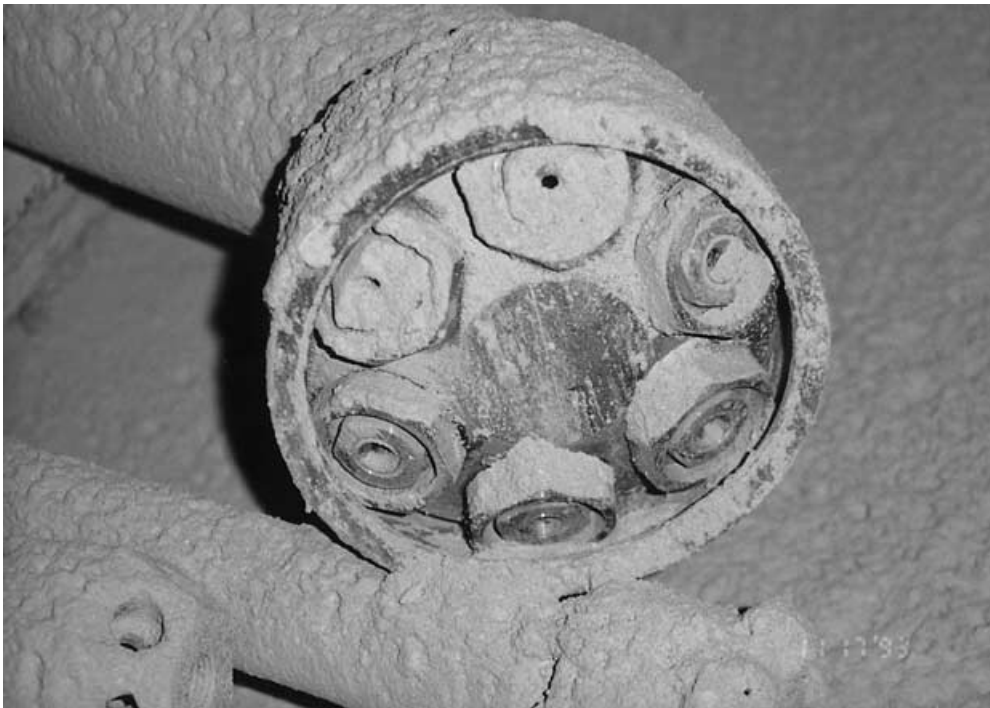
**Figure 12.9** Close-up view of spray nozzles on end of water injection cooling lance.

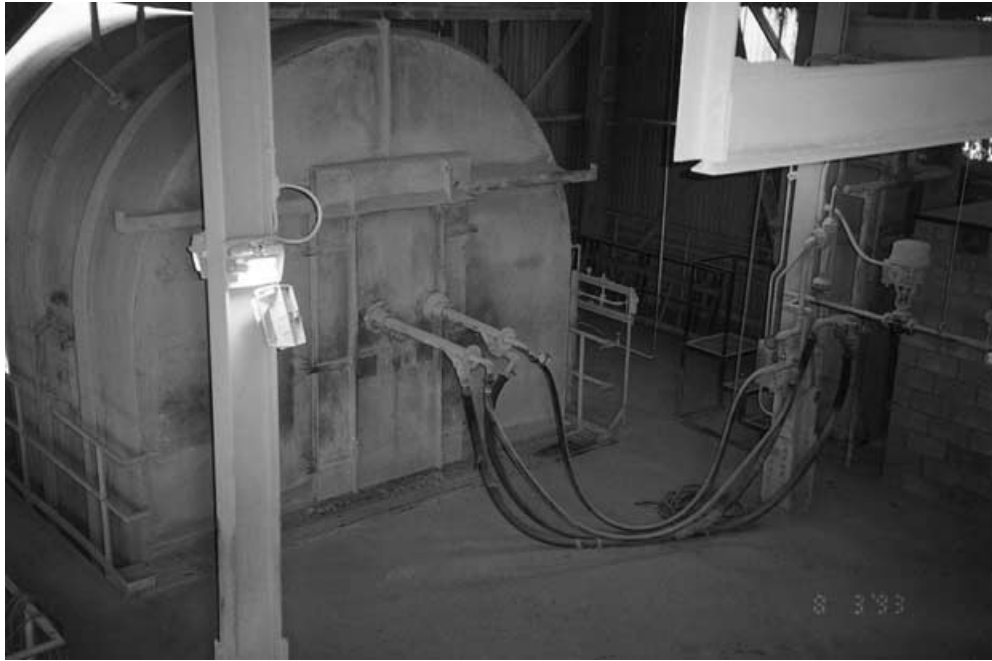
**Figure 12.10** Kiln header box with water injection cooling lances (2) (center of photo with water supply hoses attached).

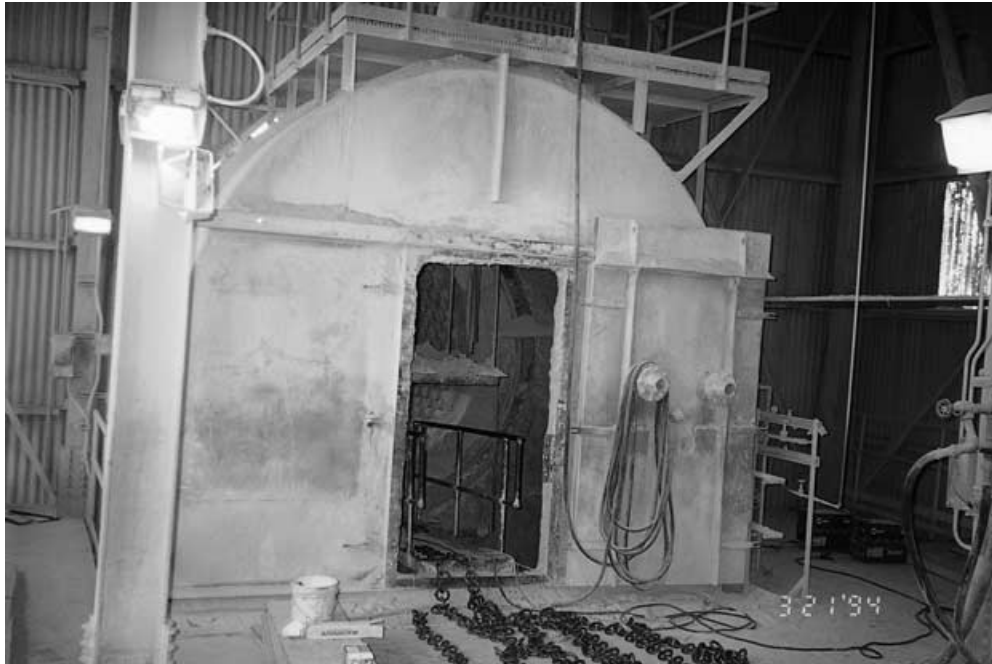
**Figure 12.11** Kiln header box access door (open) showing internal support structure and water injection cooling lance (internal connections).

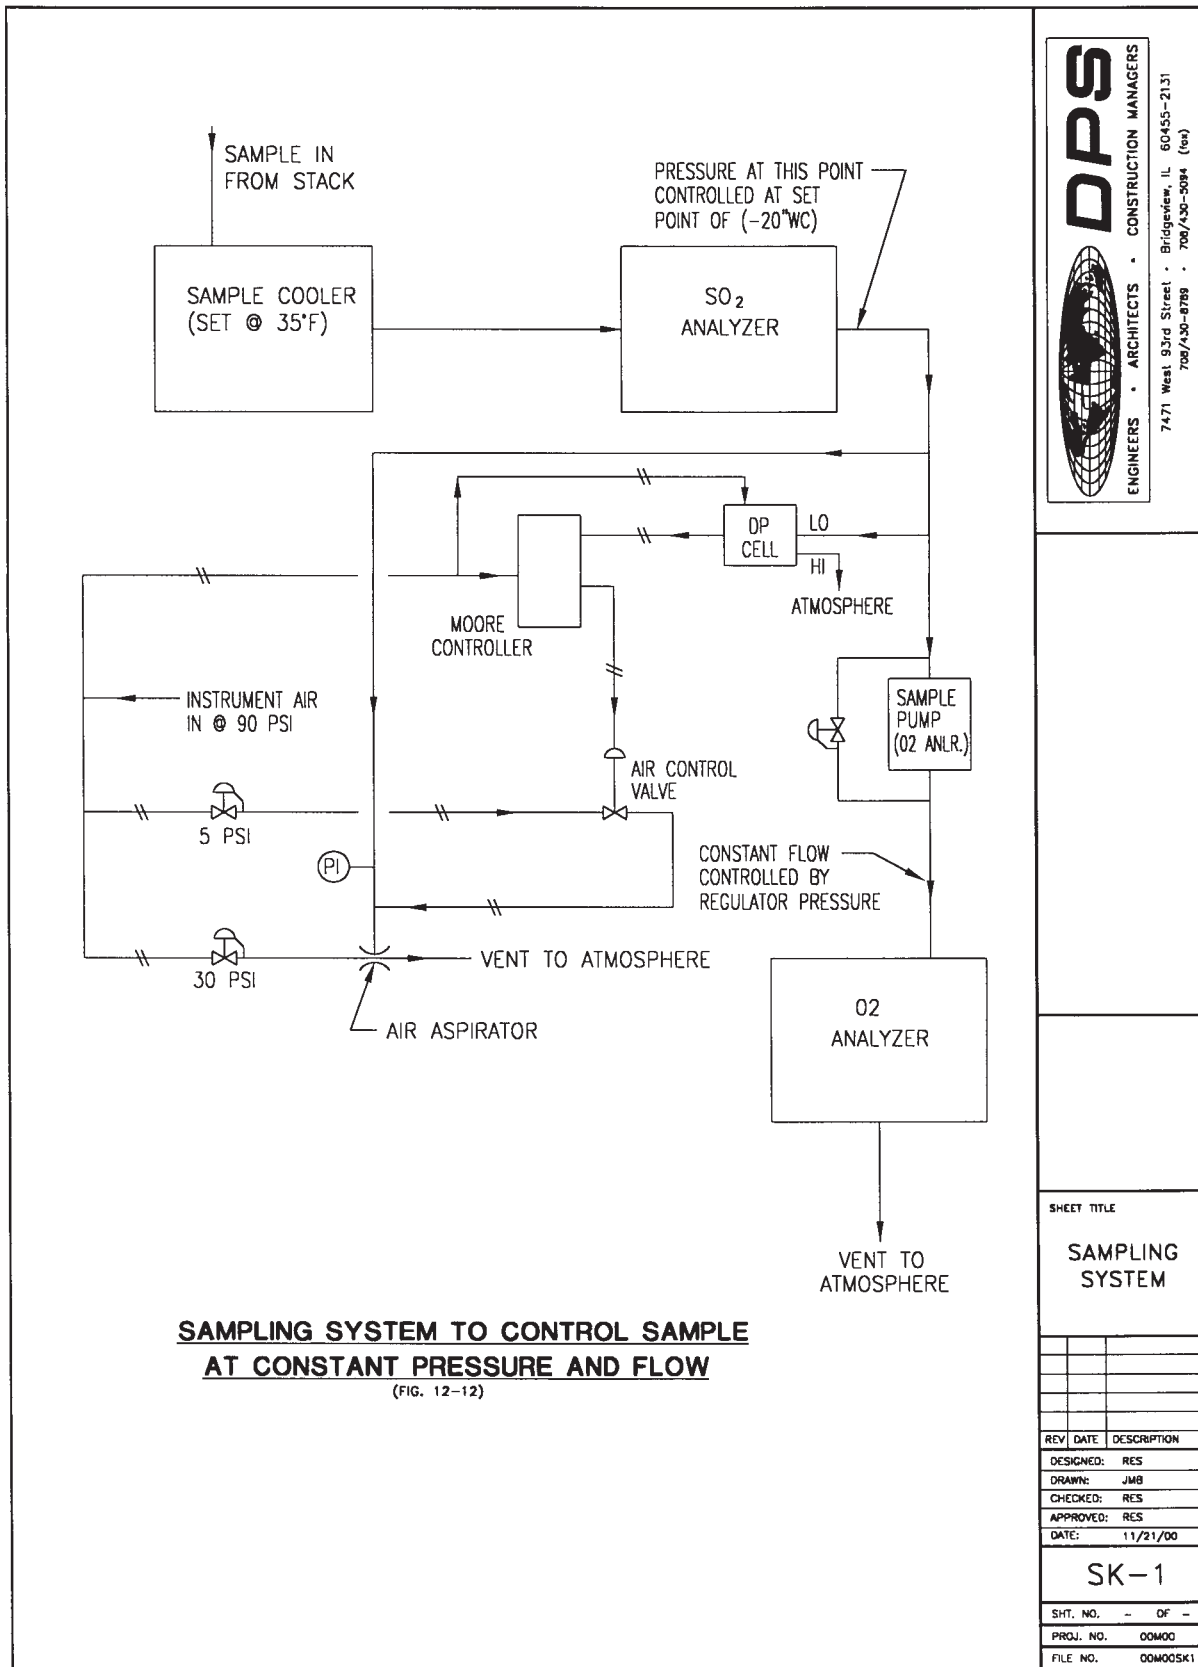
**Figure 12.12** Application schematic for analyzer sample delivery at constant pressure and constant flow rate. Reprinted, with permission, from Premcor Inc.

The following redesign was implemented nine years ago, and the system worked well until this past year with all of its original components, apart from sample cell replacements. About 60% of the components were replaced recently because of damage from their relocation with the addition of a new analyzer.
